Roof Survey

Tile Street

Survey by Moran Roofing Specialists Ltd . Lee Moran (MloR)

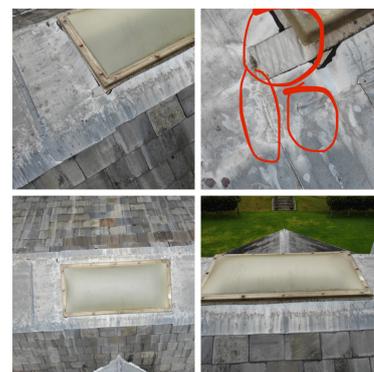
The main roof appears to have many of the original 600 x 300mm slates still in place with very few past repairs.

Looking at the drone images, I can see a dozen or so local repairs which are needed to reinstate existing slipped slates.

Having looked closely at the drone pictures, the exterior of the main roof elevations are in good working order with only minor repairs needed. When you start to see regular slipped slates, this will be a sign of nail sickness due to the fixing being that of a steel fixing instead of the recommended aluminium or copper nails.

....It's recommended an overhaul is undertaken using a cherry picker to replace up to a dozen slates. Please see below for other items recommended during the overhaul. The roof will be subject to yearly or biyearly maintenance checks to ensure longevity of the current coverings.

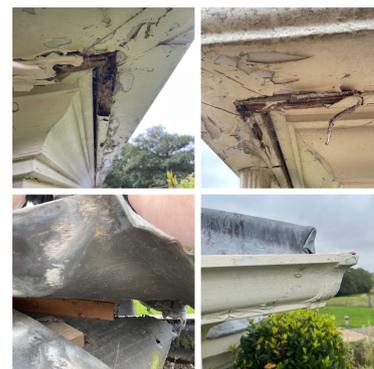
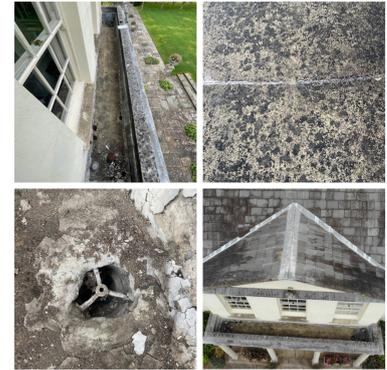
These rainwater goods are that of a seamless aluminium which has been superficially painted. The paint is flaking & will require redecoration as per your personal preference at your convenience.

to deterioration of the building especially elements built into or attached to the wall. These rainwater goods appear to have an issue at the corners. This could be an issue with the actual corner profiles themselves, or perhaps an incorrect sealant has been used. I suspect it to be one these, but can never be 100%.

All we know is there's an issue which has caused premature ageing of the bottom edges of each corner.

.....Gutters and downpipes should be checked and cleared as part of your regular maintenance plan. To gain access to the fascias, the seamless gutters will need removal, fascias can be retro fixed locally with a view to redecorate & re-fit the existing seamless rainwater goods using the correct sealant.

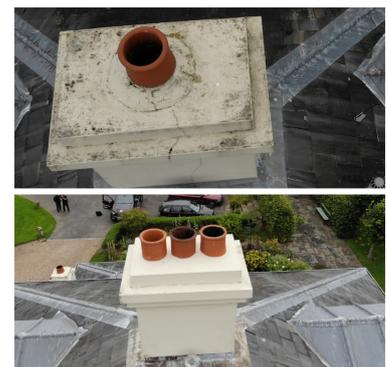
The chimneys appear to have been well maintained over the years. One chimney on the crown has had some recent work & has been redecorated.

The other chimneys have the odd superficial crack & need to be checked upon closer inspection with a view to make local repairs during.

..... The chimneys need to be checked upon closer inspection with a view to filling the cracks & redecorate. It's also advised to cover all open pots with Rain top, birdguards. Colt Cows have produced a top quality standard birdguard for gas & solid fuel burning fires, this guard has been designed to prevent unwanted water ingress, bird and animal entry to reduce the potential for clogging by soot and debris.
